Plum Bottom Closed Depression Groundwater Trace Final Report

25 January 2008

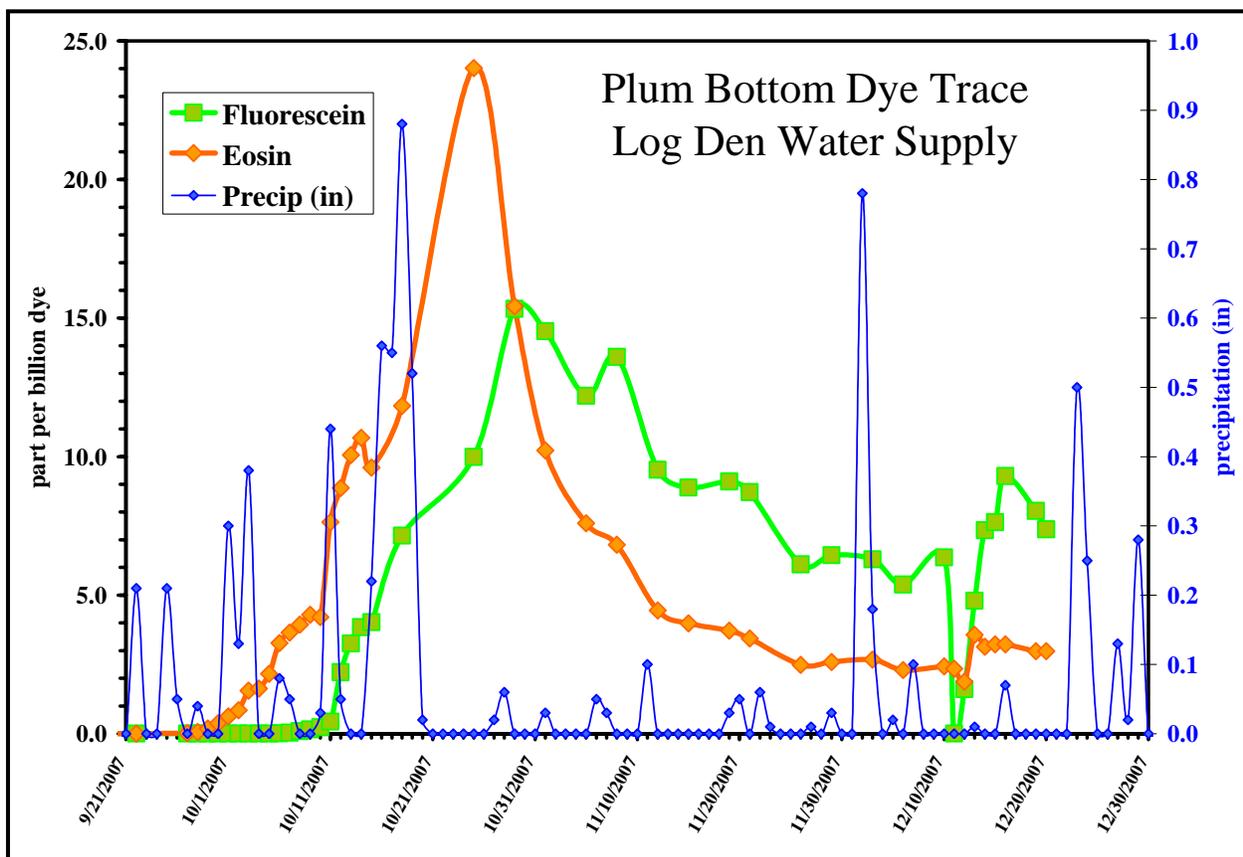
Figure 4. Eosin and fluorescein in the raw water of the Log Den well.

local rainfall data is shown. The concentration of the eosin and to a lesser extent the fluorescein appear to be increase after local rainfalls. The dip in the fluorescein on 10-12 December 2007 and the smaller dip in the eosin data were the dye reaction to a shock chlorination of the well, which was done as part of routine maintenance to control iron bacteria. The effect of the chlorination on the dye was only evident for 2-3 days.

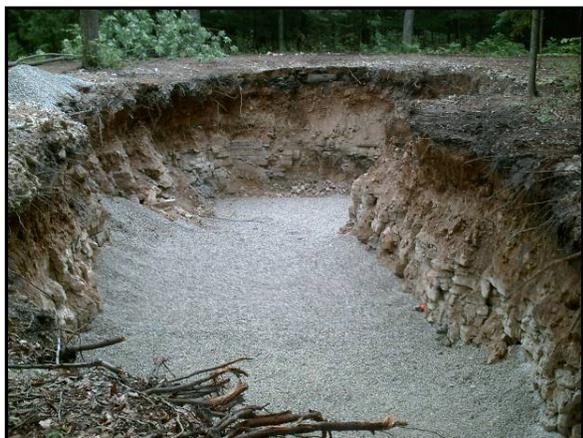
One potential path is at the dosing chamber and septic tanks that were set on gravel over bedrock (Figs 5 and 6). At those sites, any effluent leaking from the system would not pass through soil and there would be very little opportunity for pathogen attenuation. That mechanism can explain the rapid breakthrough of the eosin dye that was introduced into the system from the

Figure 5. The septic tank trench was dug into bedrock and back filled with gravel.

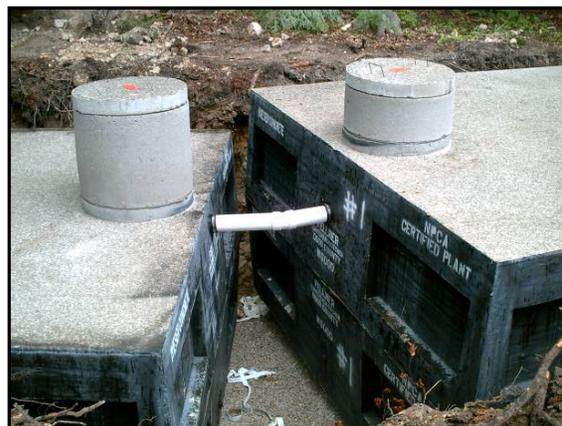
Figure 6. Two of the septic tanks' connecting pipe.

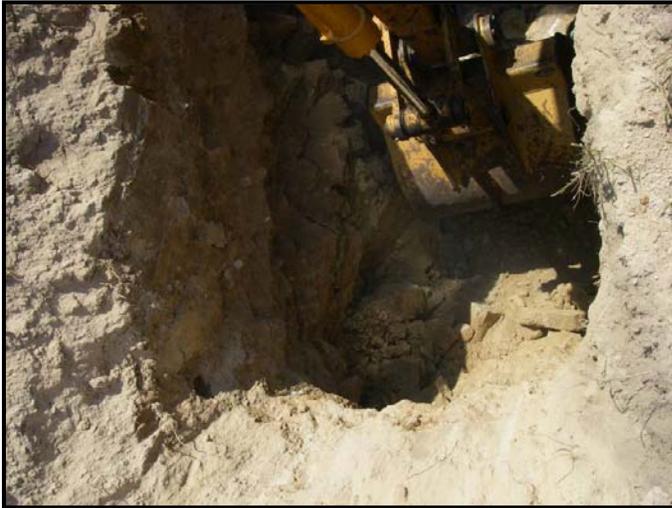
decreasing both the effluent's travel time to the bedrock and the opportunity for pathogen removal. The drain field and the trenches leading to the drain field are also underlain by fractured, highly permeable karst bedrock (Fig 7). This second scenario accommodates the different break through times more easily than does the first scenario. Were a leak in or near the dosing chamber the fluorescein short-circuit, the fluorescein should have arrived at the well in a similar time period as the eosin.

Figure 7. Fractured karst bedrock in a test pit immediately adjacent to the Log Den drain field. Photo by Chris Olson.

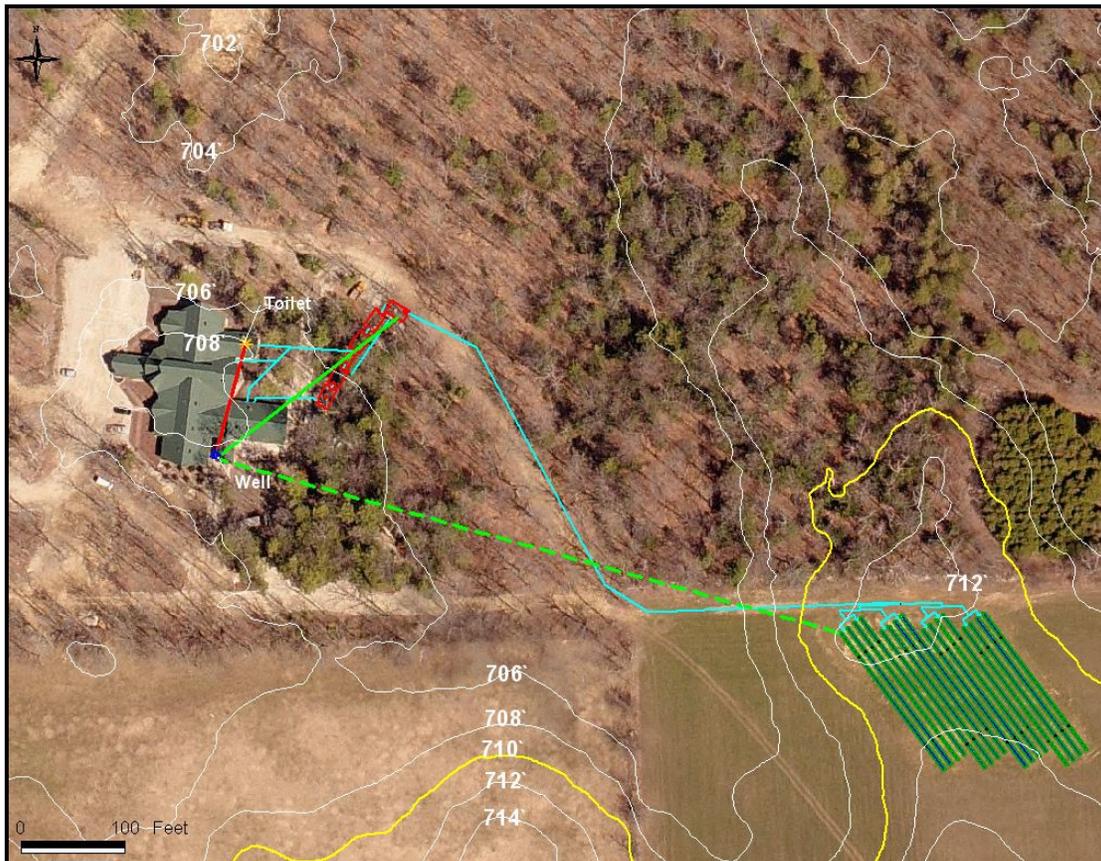
Figure 8. Log Den Restaurant Site Map plan view with diagrammatic dye connections shown.

The dye trace connections at the Log Den can be visualized in either plan (Fig. 8, above) or cross section (Fig. 9, below). In Figure 8 the red line from the “Toilet” to the well signifies a very direct, fast path between materials flushed down the toilet and the water supply well with little if any attenuation. The solid light green line shows a diagrammatic dye connection via a leak from the dosing chamber to the aquifer to the water supply well. The dashed light green line shows a diagrammatic connection between effluent that reaches the drain field and then short circuits to the aquifer and the water supply well.

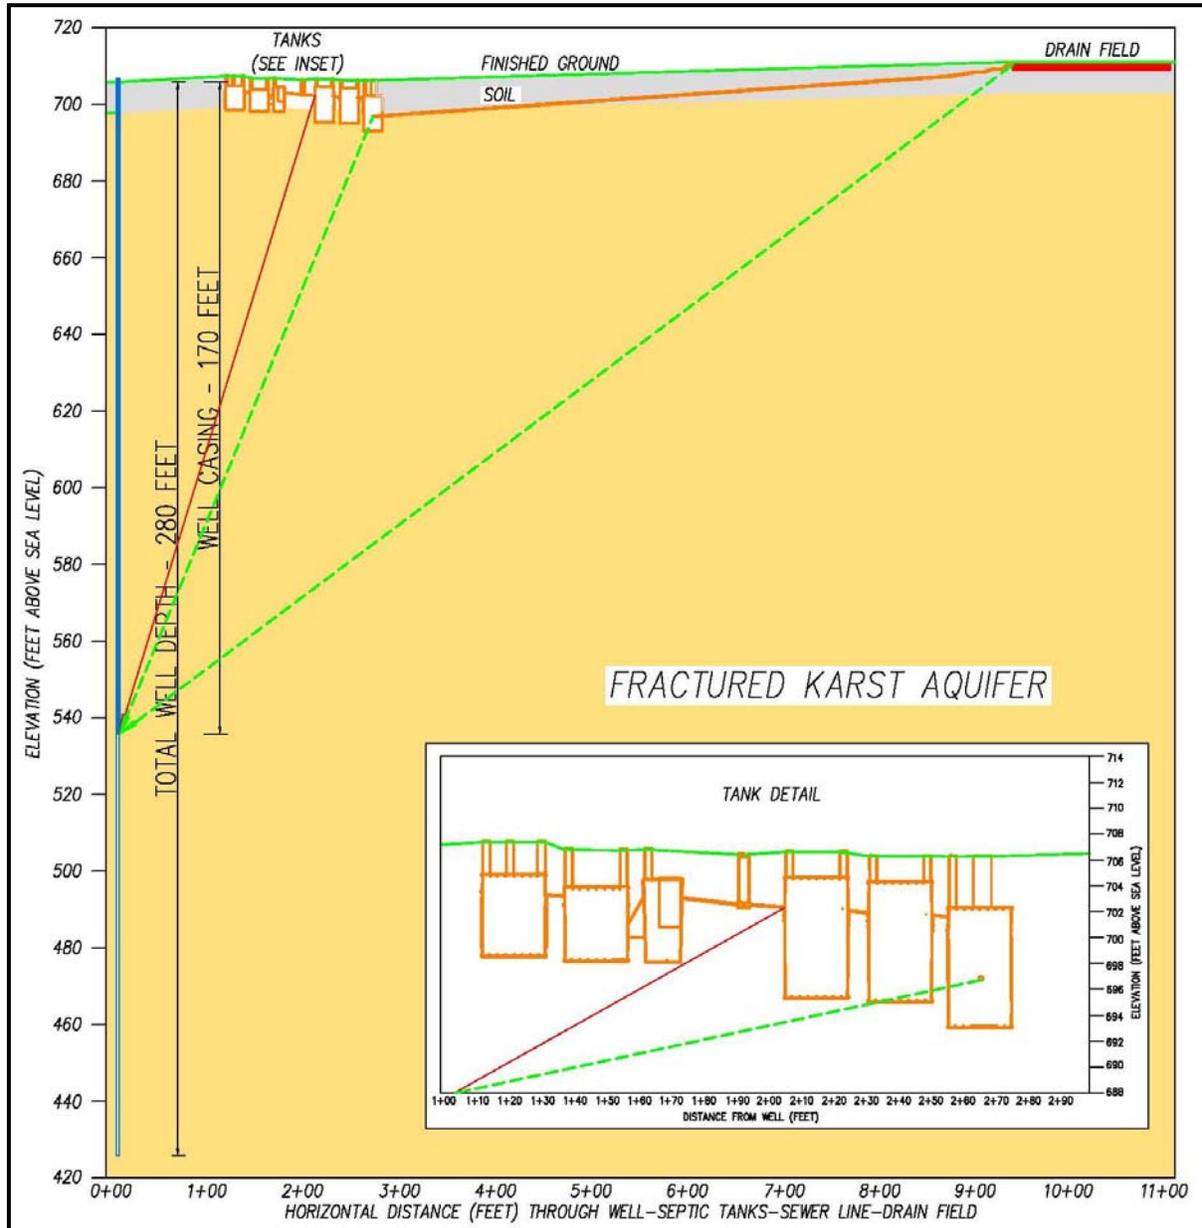
Figure 9. Cross section from Log Den water supply well through the septic tanks and then along the sewer line to the drain field. ~ 5x vertical exaggeration.

Figure 9 shows the same diagrammatic flow paths but in cross section. The eosin from the toilet entered the groundwater very directly and part of it moved downward (in response to pumping) to at least the bottom of the well casing and then was pumped back up the well into the

Log Den. An possible eosin path is show in Figure 9 as the red line reaching the septic tanks through the sewer line, leaking into the installation pit and then into the aquifer. An alternative path could be along a foundation trench to the top of the well, down the outside of the well and then back up the inside.

Figure 9 show as dashed green lines two possible paths for the fluorescein poured into the dosing chamber. One assumes that some sort of leak occurred near the dosing chamber, flowed to the aquifer and through the aquifer to at least the bottom of the well casing. A second possible path assumes the dye reached the drain field, short circuited there and flowed through the aquifer to the well.
