Plum Bottom Closed Depression Groundwater Trace Final Report

25 January 2008

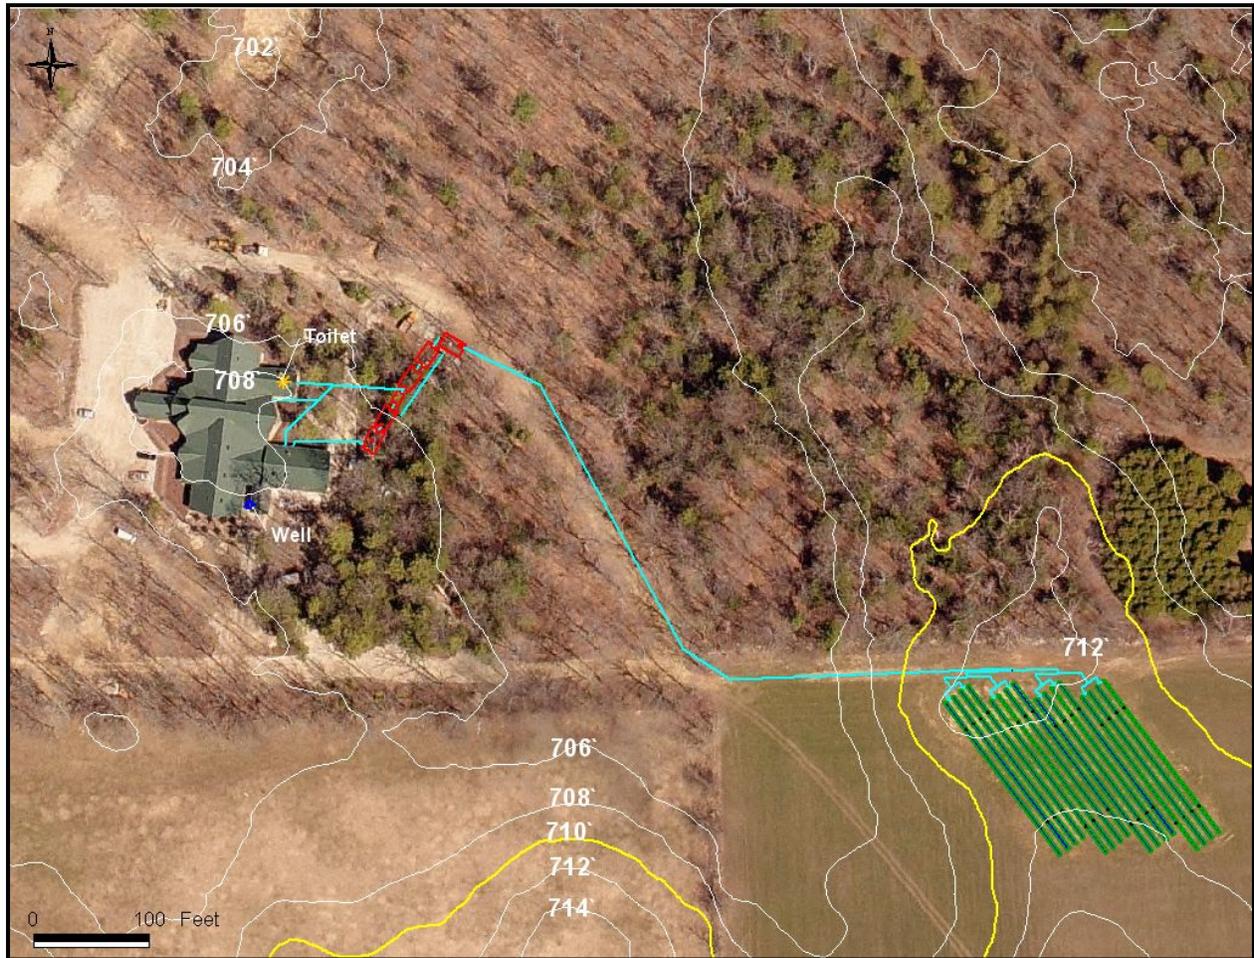
Figure 1. Log Den Restaurant site map. The drain field is show in green. The septic tanks and dosing chamber are shown in red. The sewer lines are shown in aqua.

Figure 1 is an air photo of the Log Den Restaurant with the plumbing features superimposed from the as-built plans. The air photo was taken 20 April 2007 shortly before the Log Den opened for business. The water supply well is indicated.

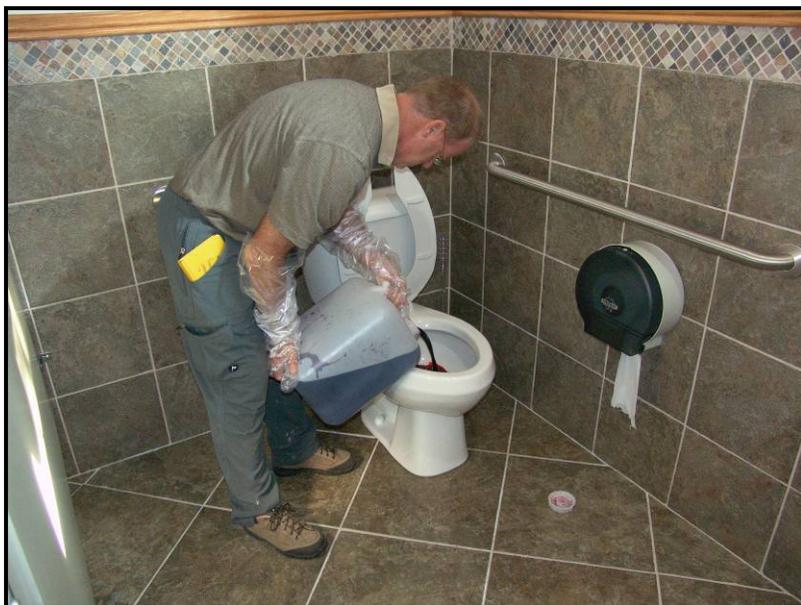
Eosin was poured into the men’s restroom toilet in the northeast corner of Log Den Restaurant at 10:30 AM on 21 September 2007 (Figure 2). Fluorescein was poured into the dosing chamber at the end of the chain of septic tanks at 10:05 AM on 21 September 2007 (Figures 3 and 4). The dosing chamber pumped a dose of dye and effluent toward the drain field immediately after the fluorescein was poured.

Figure 2. Scott Alexander pouring eosin into a toilet in a rest room in the Log Den Restaurant. Photo by Brian Forest.

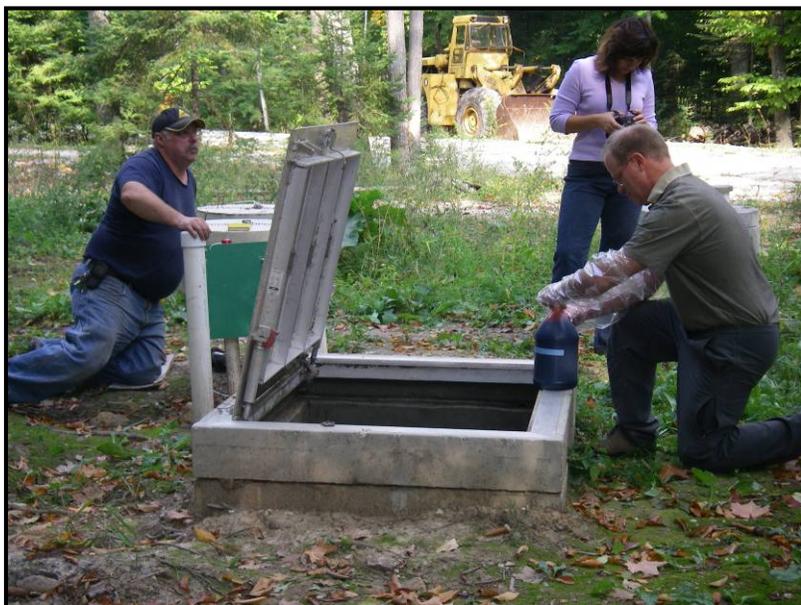
Figure 3. Scott Alexander pouring fluorescein into the dosing chamber of the Log Den's waste water treatment system. Photo by Chris Olson.
